Marine Investigation Preliminary Report

Contact of Containership *Dali* with the Francis Scott Key Bridge and Subsequent Bridge Collapse

| Location: | Baltimore, Maryland | Accident Number: | DCA24MM031 |
| Date and Time: | March 26, 2024 0129 local time (eastern daylight time) | IMO Number: | 9697428 |

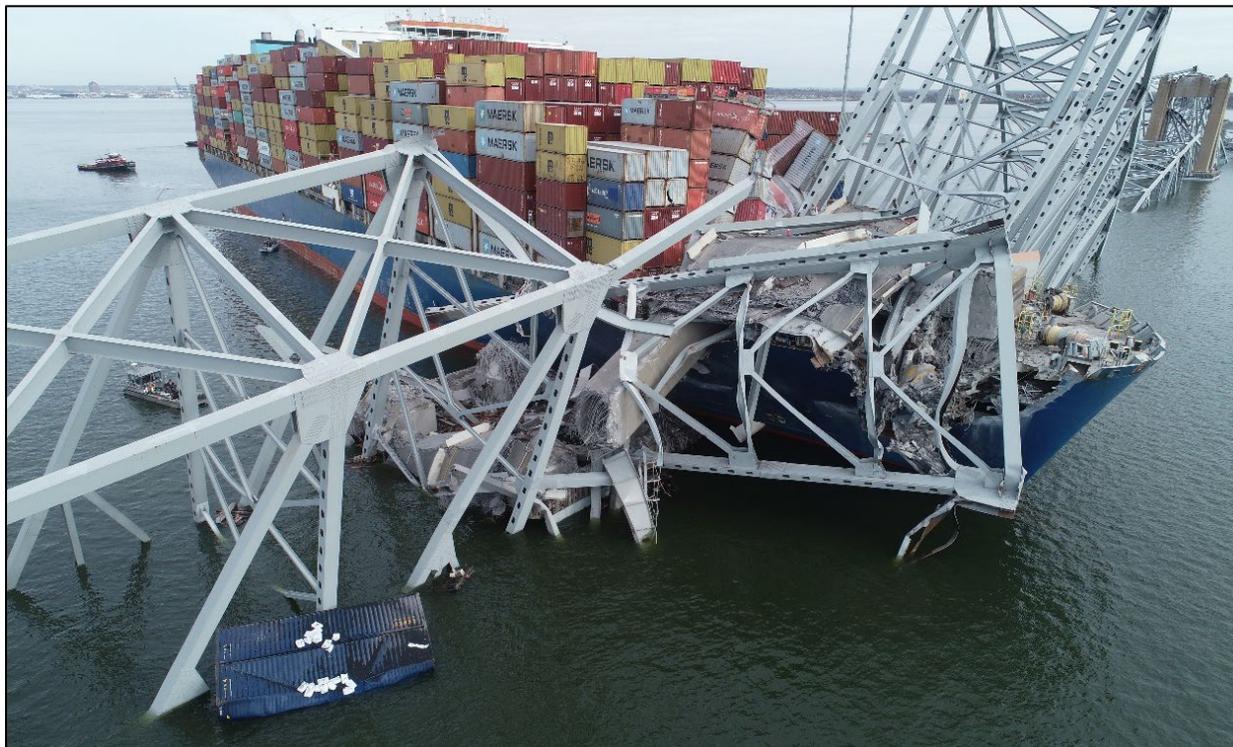
Figure 1. The *Dali*, with portions of the collapsed Key Bridge across its forward deck and in the Patapsco River, on March 28.

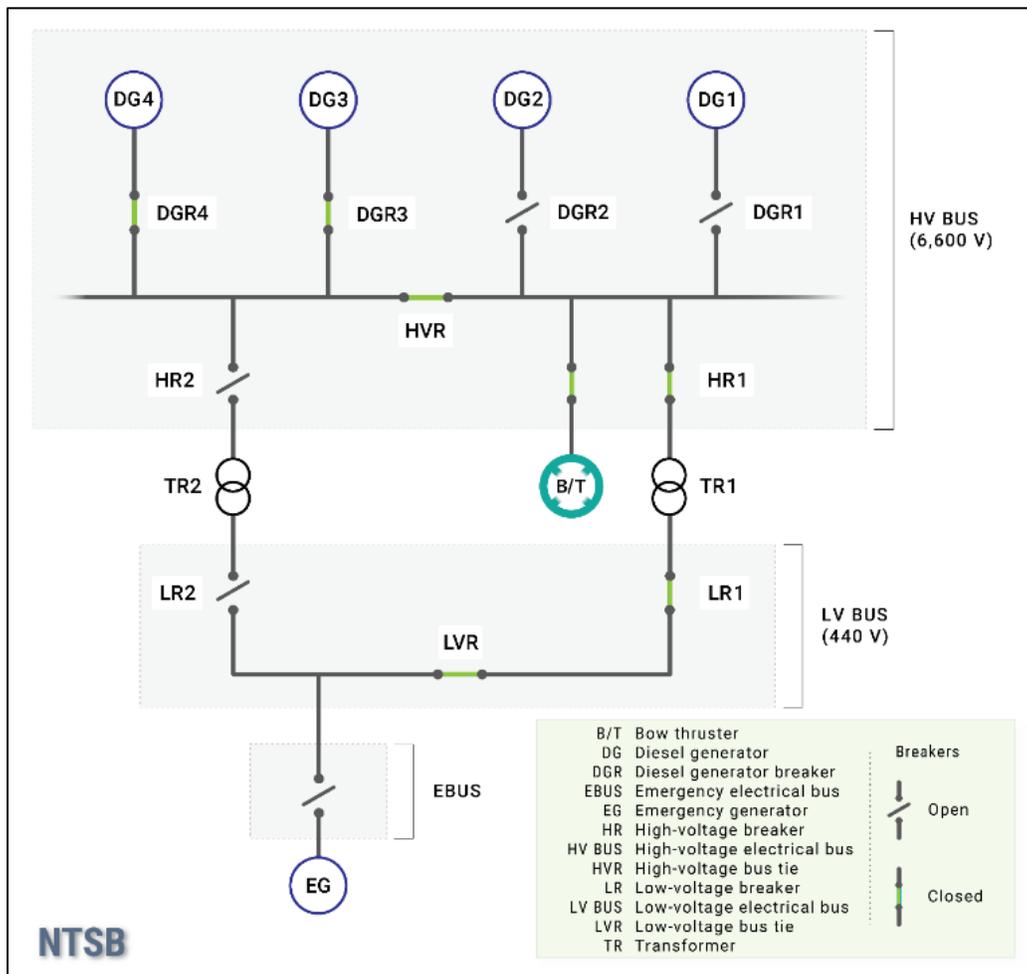
Figure 5. Simplified one-line electrical diagram of the *Dali* electrical power distribution system. Breakers shown reflect their positions at departure on March 26.

About 0125, the *Dali* was 0.6 miles—or three ship lengths—from the Key Bridge when electrical breakers (HR1 and LR1) that fed most of the vessel's equipment and lighting unexpectedly opened (tripped) (see figure 7). This caused the first blackout (loss of electrical power) to all shipboard lighting and most equipment, including the main engine cooling water pumps (which controlled engine cooling water pressure) and steering gear pumps.

- The *Dali* crew was able to restore electrical power to the vessel, but, when the ship was 0.2 miles from the bridge, a second electrical blackout occurred because DGR3 and DGR4, the breakers that connected generator nos. 3 and 4 to the HV bus, opened, causing a total loss of vessel electrical power (HV bus and LV bus). Having connected to the emergency bus by this time, the emergency generator provided electrical power to the emergency equipment continuously through the second electrical blackout.
- Generator no. 2, which had previously started automatically because it was in standby mode, connected and restored power to the HV bus via DGR2.

The first vessel blackout after departure on March 26 occurred when the HR1 and LR1 breakers opened unexpectedly.

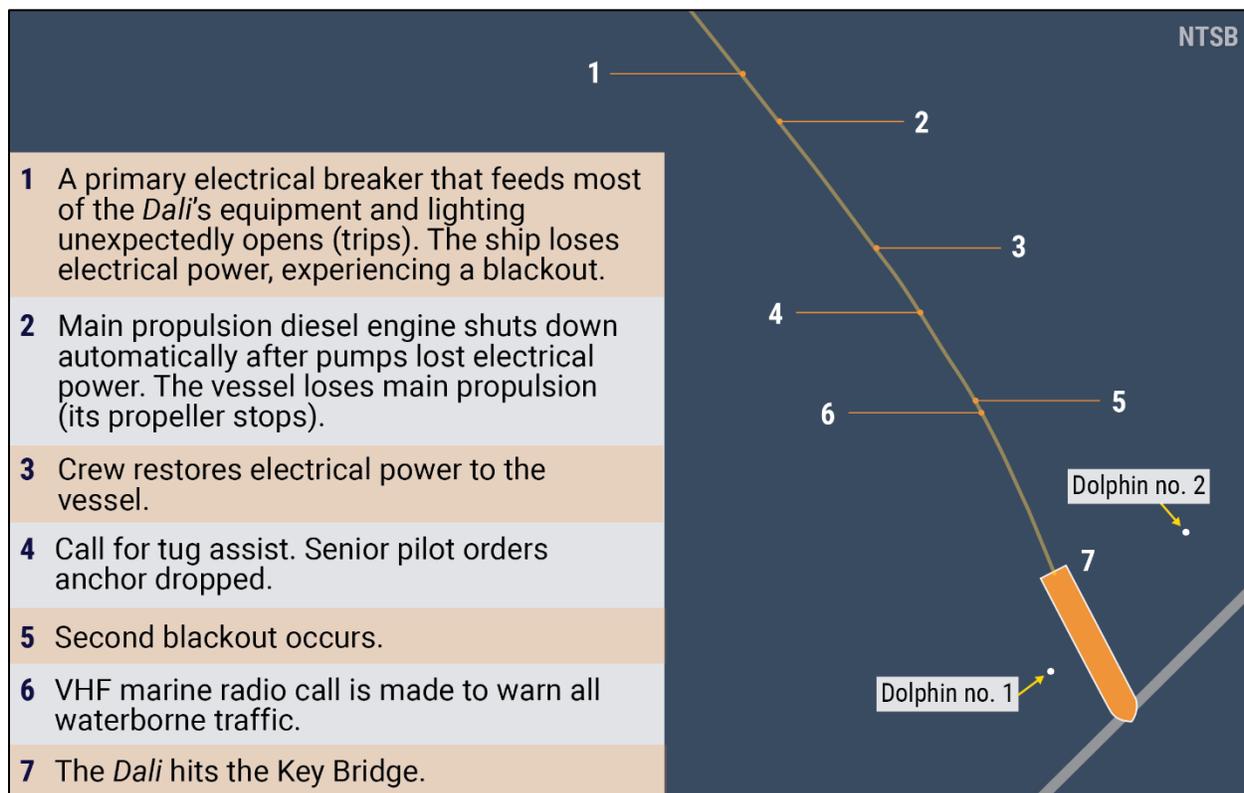
Figure 7. The *Dali*'s route on March 26, between the first blackout, and the *Dali* striking pier no. 17 of the Key Bridge. The location and approximate size of two of the bridge's "dolphins," sheet pile and concrete structures protecting the bridge's piers, are labeled in the lower right.

At 0129:10, the *Dali's* starboard bow struck pier no. 17 of the Key Bridge at 6.5 knots. Six spans of the bridge (the main spans [17, 18, and 19] and spans 20, 21, and 22) subsequently collapsed into the water and across the ship's bow. A *Dali* crewmember, who was on the bow at the time of the accident, told investigators that, as he was releasing the brake on the port anchor, he had to escape from the falling bridge before he was able to reapply the brake. (Due to ongoing salvage efforts, the amount of anchor chain paid out is still unknown.)

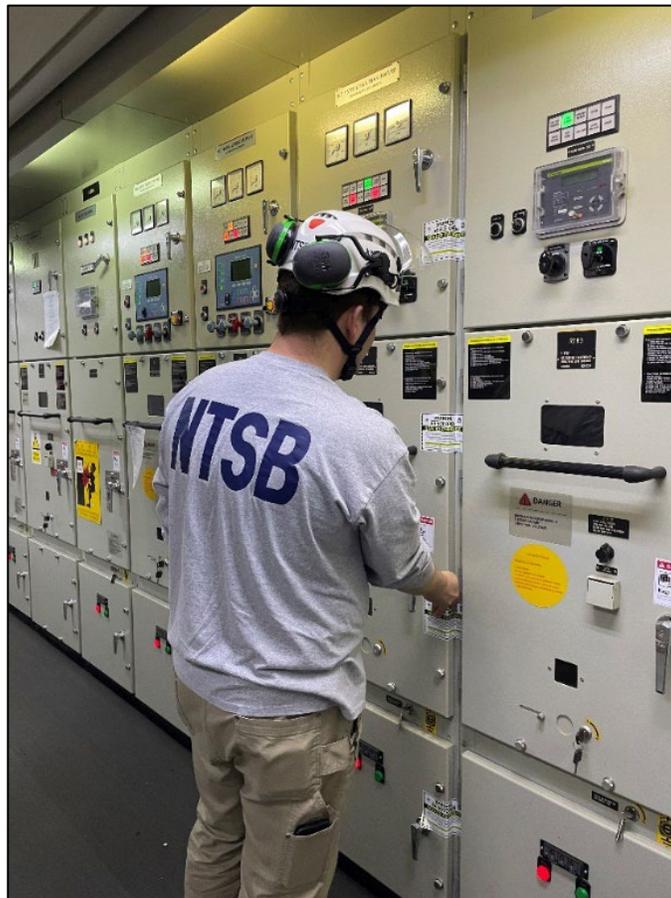
The *Dali* was equipped with an integrated control and monitoring system (ICMS) that retained information related to machinery and system changes and resulting alarms, including vessel engines and the electrical power management system. The NTSB has managed testing of the vessel's HV electrical bus and its components (including the HV and LV breakers) as the investigation parties and the electrical bus manufacturer, HD Hyundai Heavy Industries, Co. Ltd., work to identify the cause(s) of the breakers unexpectedly opening while approaching the Key Bridge and the subsequent blackouts (see figure 8).

Figure 8. An NTSB investigator examining the *Dali*'s HV switchboard (which houses the HV bus) and applying tamper-evident preservation seals.

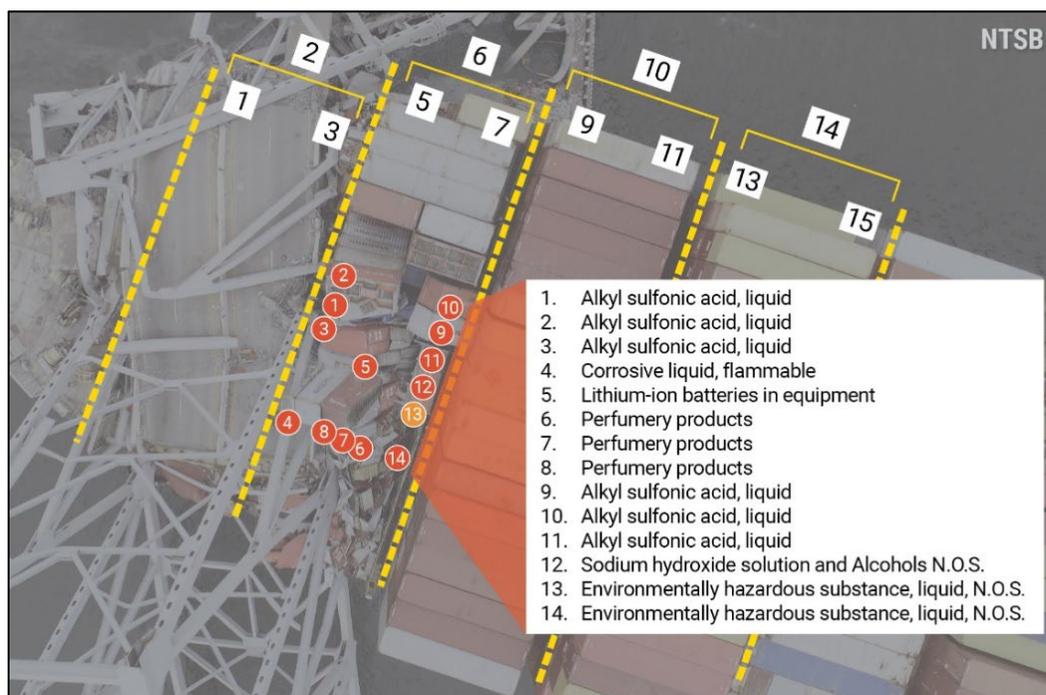
Of the 4,680 containers on board the vessel at the time of the accident, 56 were identified as containing dangerous goods (hazardous materials). The containers were located throughout the ship. The NTSB identified 14 containers, which were recorded as containing hazardous materials, that may have been damaged when the ship struck the Key Bridge or during the subsequent collapse of the bridge deck onto the ship (see figure 9 and table below). These 14 containers were all located forward of the superstructure, inboard in bays 5, 6, and 7.⁹

Figure 9. Approximate locations of cargo bays (yellow with numbers in white squares) and the 14 impacted hazardous materials shipping containers (orange circles with white numbers) transposed onto the *Dali* as seen after the accident. Hazardous material container no. 13 was in a portable tank, stored in the hold, below the deck.

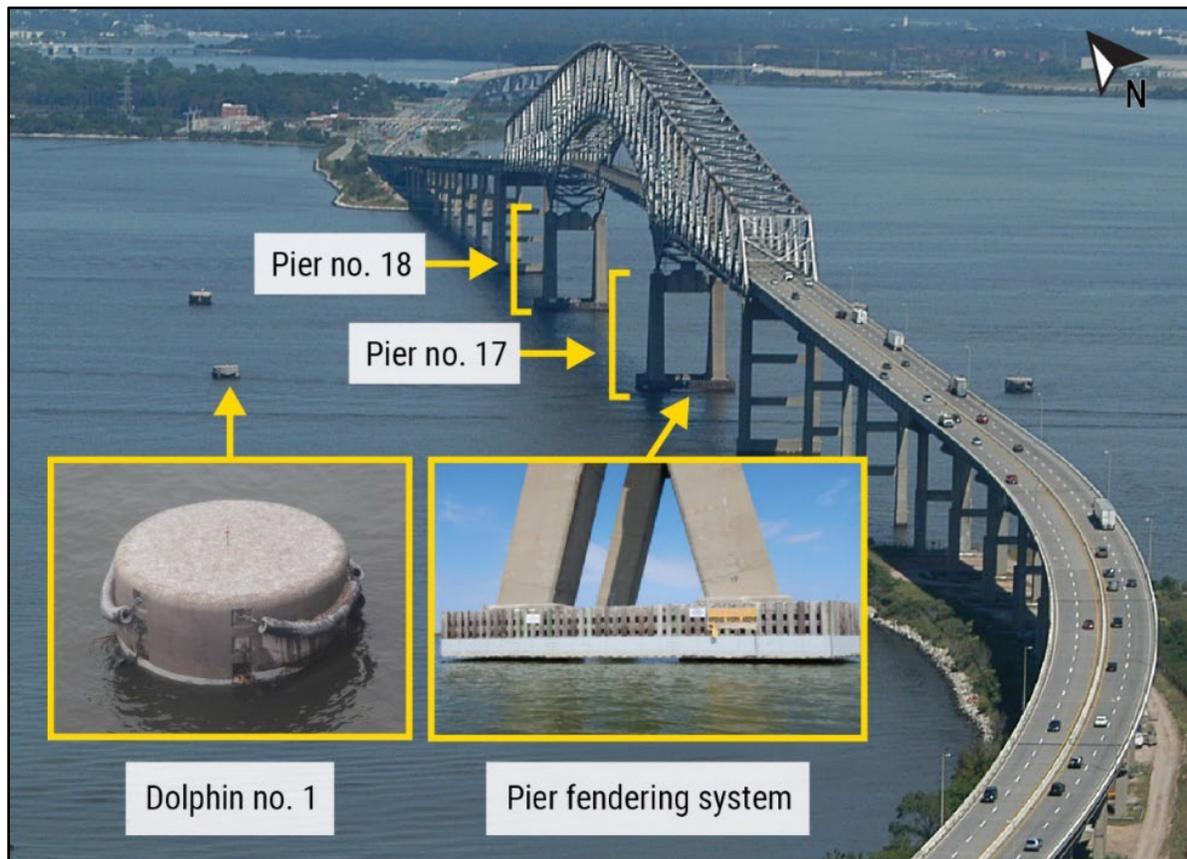
Figure 12. The Key Bridge and the locations of pier nos. 17 and 18. Insets show dolphin no. 1 as well as pier no. 17's fendering-system surrounding. (Background source: MDTA)

In addition to the dolphins, pier nos. 17 and 18 were each surrounded by a 100-foot-by-84.5-foot crushable concrete box and timber fender system, as seen in figure 12. These systems were comprised of hollow, thin-walled, concrete box structures attached to the piers. The timber portions of the fender were attached to the outer face of the concrete box and utilized a combination of vertical and horizontal members. Additionally, steel plates were secured at the base of the vertical timber members.

The *Dali* struck pier no. 17 and the fendering system surrounding the pier but did not contact dolphin no. 1 or its rubber fenders. Both fendering systems surrounding pier nos. 17 and 18 were further damaged during the collapse of the truss spans of the bridge when components of the truss spans impacted portions of the fenders as the components fell into the water.
