Marine Investigation Preliminary Report

Contact of Containership *Dali* with the Francis Scott Key Bridge and Subsequent Bridge Collapse

| Location: | Baltimore, Maryland | Accident Number: | DCA24MM031 |
| Date and Time: | March 26, 2024 0129 local time (eastern daylight time) | IMO Number: | 9697428 |

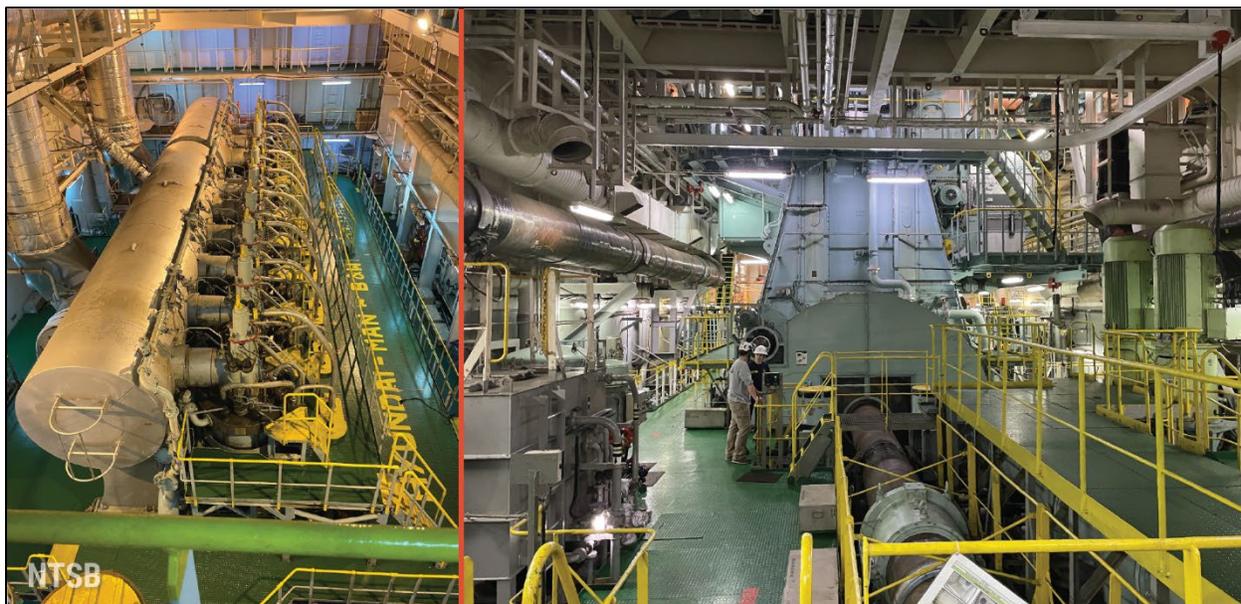
Figure 2. Left: The *Dali*'s main engine room (looking aft), showing the vessel's engine. Right: NTSB investigators examining the lower level of the vessel's engine room (looking forward).

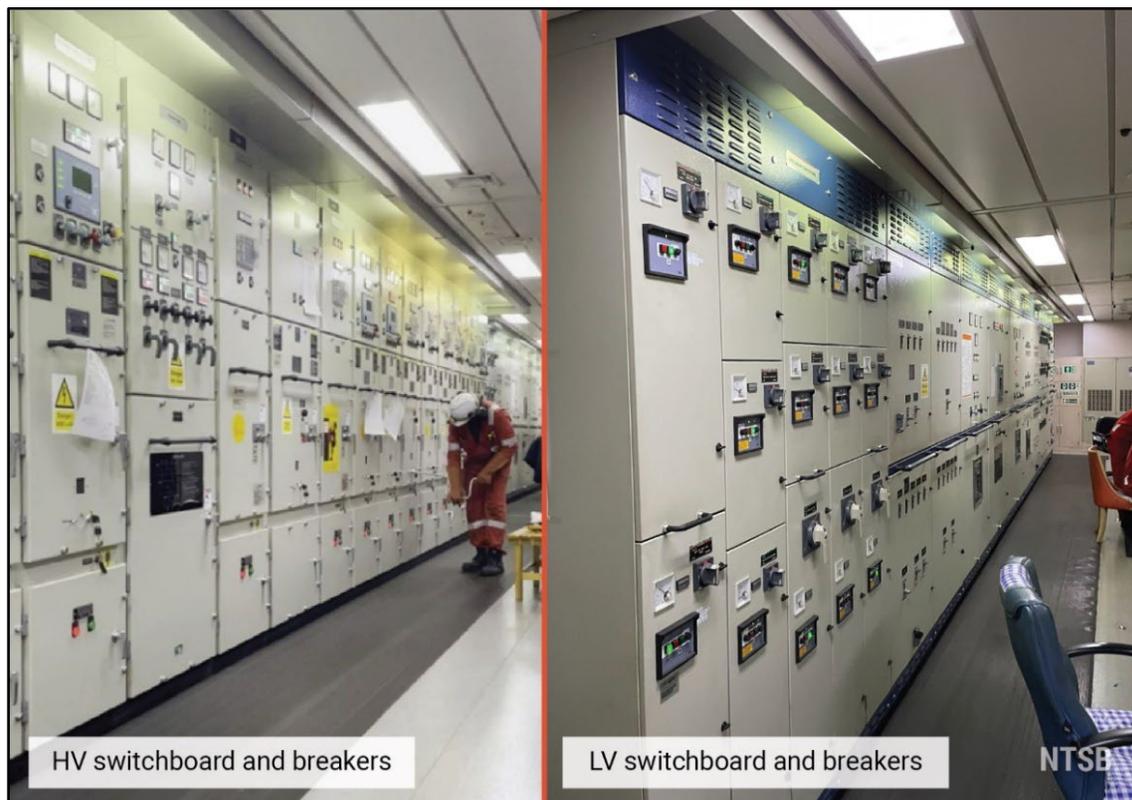
Figure 3. The *Dali*'s power management system in the ship's engine control room. The HV switchboard (which houses the HV bus) and breakers (*left*) and the LV switchboard (which houses the LV bus) and breakers (*right*).

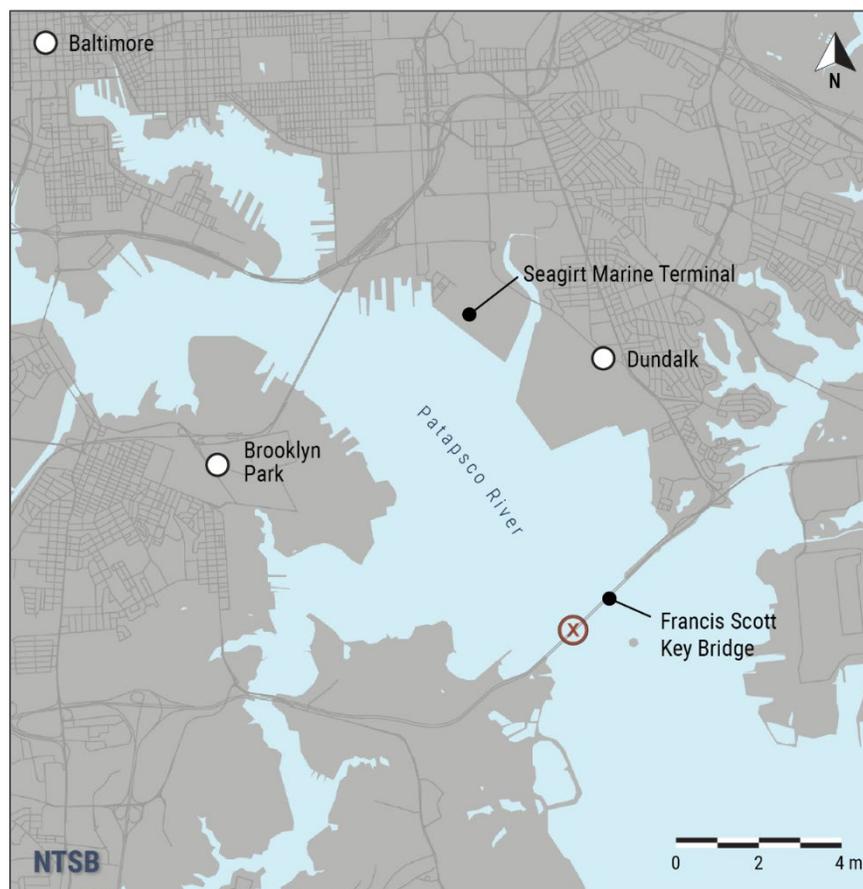
Figure 4. Area where the *Dali* struck the Key Bridge, as indicated by the red X. (Background source: Google Maps)

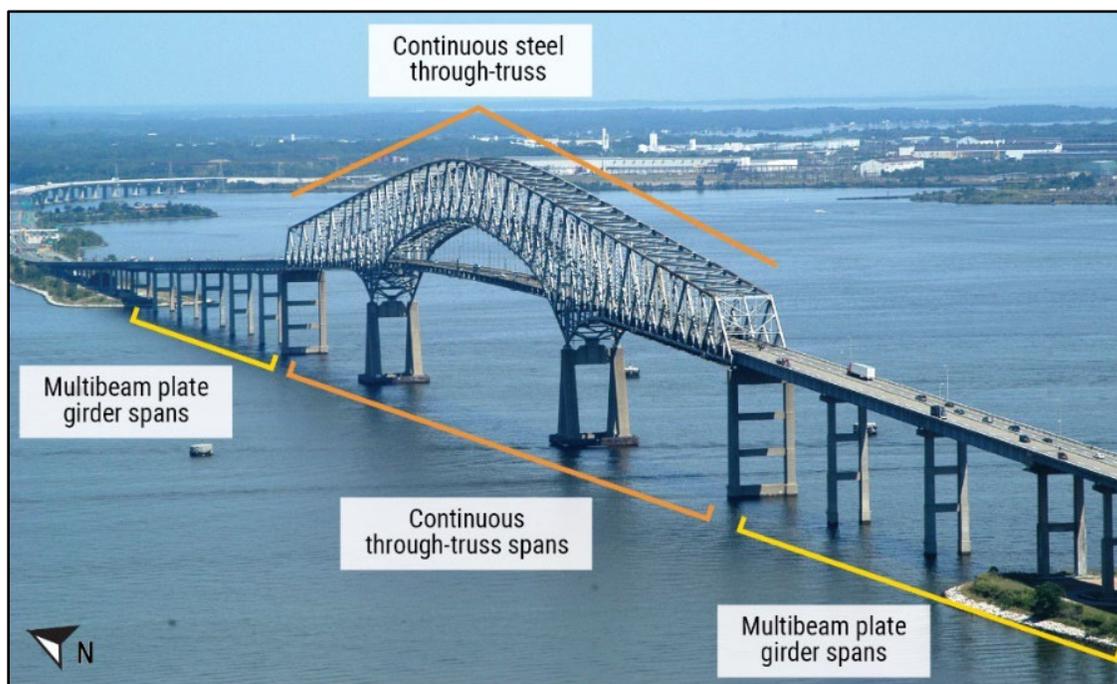
Figure 10. The Key Bridge with its truss and spans labeled. (Background source: MDTA)

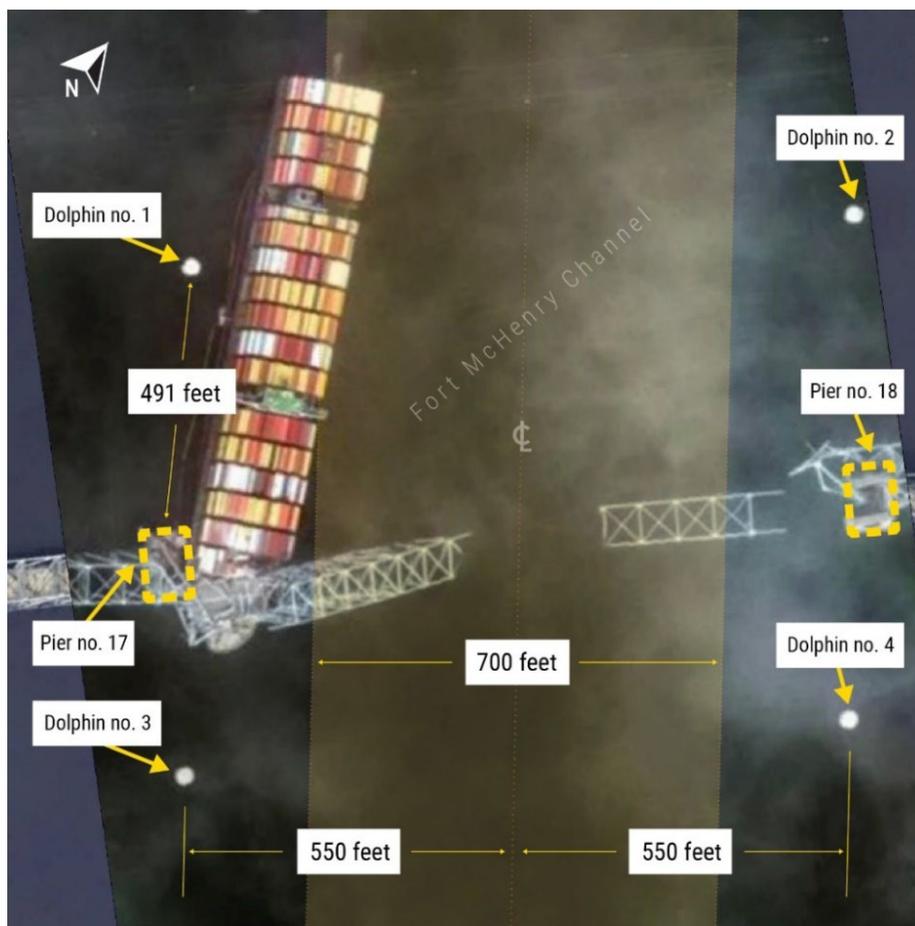
Figure 11. Locations of dolphins relative to the *Dali*, the Key Bridge, and Fort McHenry Channel. (Background sources: MAXAR and Google Earth)
